Manhole Inspection Summary

Manhole # S17EE_001MH

Location Address: **1308 BENTALOU AT**

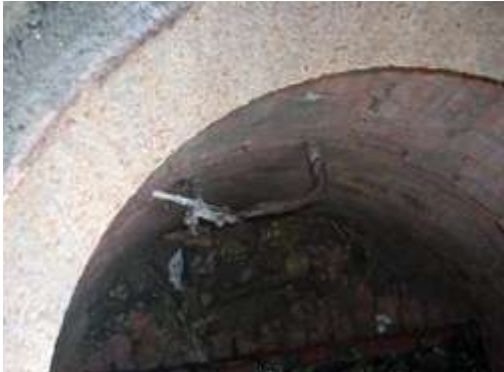
Defect 3

Steps Count: **1** Missing: **0** ☒ **Corroded**

Surcharge ☒ **Evidence Of Surcharge** Depth: **2** (ft.) ☐ Active Surcharge Present

CORRODED STEP WITH SURCHARGE EVIDENCE

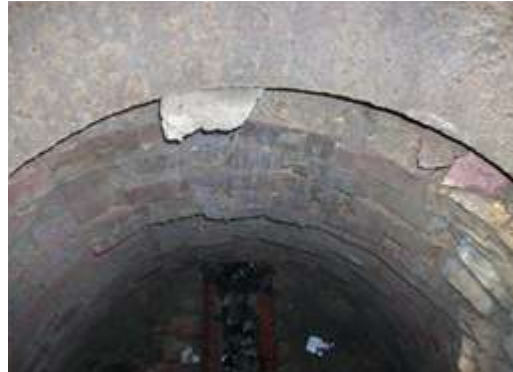
Defect 2

Infiltration: ☐ None ☒ **Joint** ☐ Cracks ☐ Mortar ☐ Roots ☐ Wall

INFILTRATION OF JOINT

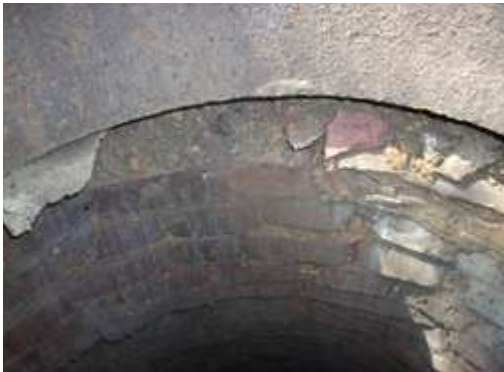
Defect 1

Condition: ☐ Sound ☐ Cracked ☐ Root Intrusion ☐ Loose Brick ☒ **Deteriorated**

DETERIORATION OF CORBEL

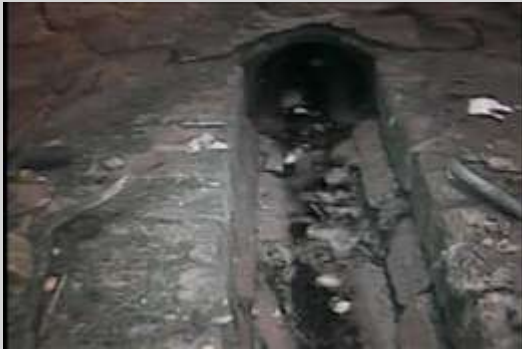
12 O'Clock Outflow

8 in. Circular Gravity Sewer
Pipe Out @ 12 O'Clock

Pipe Height: **7.2** (in.) Rod and Bar (Angled)
Pipe Material: **Clay** ☐ Pipe Lined
Invert Depth: **5.28** (ft.) Flow Characteristics: **Slow**
Deposits: ☒ None ☐ Mud ☐ Sludge ☐ Debris ☐ Grease
Silt Depth: (in.) Deposits Extent:
Infiltration: **None** Pipe Seal Cond: **Broken**

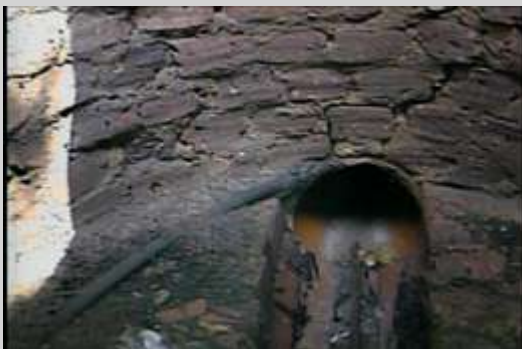
6 O'Clock Inflow

8 in. Circular Gravity Sewer
Pipe In @ 6 O'Clock

Pipe Height: **8.4** (in.) Rod and Bar (Angled)
Pipe Material: **Clay** ☐ Pipe Lined
Invert Depth: **5.02** (ft.) Flow Characteristics: **Slow**
Deposits: ☒ None ☐ Mud ☐ Sludge ☐ Debris ☐ Grease
Silt Depth: (in.) Deposits Extent:
Infiltration: **None** Pipe Seal Cond: **Cracked**
